Geologic Hazards Photos Volume 1

Earthquakes - General Topics

Earthquake Damage General Information

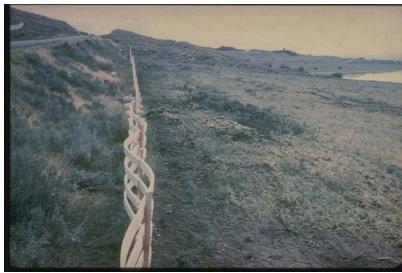
Compression of Fence, Hebgen Lake, Montana Earthquake of August 18, 1959, Hebgen Lake, Montana. The magnitude 7.1 earthquake killed 28 people and caused \$11 million property damage.

GROUND DEFORMATION-COMPRESSSION This snake-like fence at Culligan's ranch (about 1 km east of Red Canyon entrance and less than 20 km from the Montana epicenter) is a result of compression as soils moved downhill during the quake. Movement along a fault running through the Culligan's property damaged practically all the buildings. Photograph Credit: U.S. Geological Survey (J.R. Stacy).

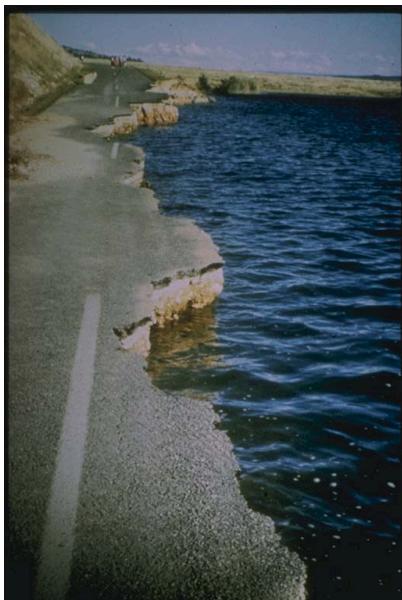
Slumping of Highway into Hebgen Lake, Montana Earthquake of August 18, 1959, Hebgen Lake, Montana. The magnitude 7.1 earthquake killed 28 people and caused \$11 million property damage.

GROUND DEFORMATION-SLUMPING A section of Highway 287 has crumbled into Hebgen Lake. Landslides, submersion, cracking, and shifting of the roadway made the road impassable for a distance of nearly 58 km. Over 200 vacationers were trapped in Madison Canyon when the earthquake destroyed whole sections of highway. Timber and road damage were estimated at \$11 million. Photograph Credit: University of California, Berkeley.

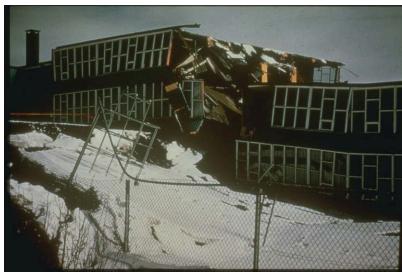
Earthquake of March 28, 1964, Prince William Sound, Alaska. The magnitude 8.5 earthquake killed 131 people and caused \$538 million in property damage. An area consisting of 120,700 km² was shaken with damaging intensity.

GROUND DEFORMATION-SLUMPING Photo shows extent of subsidence at Government Hill School in Anchorage. Soils failed and moved down slope. The soil failure left a part of the school on unmoved ground and dropped the remainder into a wide trough or graben. Photograph Credit: National Geophysical Data Center.

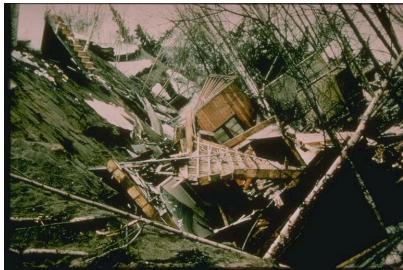
Slumping of Turnagain Heights Subdivision, Anchorage, Alaska Earthquake of March 28, 1964, Prince William Sound, Alaska. The magnitude 8.5 earthquake killed 131 people and caused \$538 million in property damage. An area consisting of 120,700 km² was shaken with damaging intensity.

GROUND DEFORMATION-SLUMPING Slumping of the entire Turnagain Heights subdivision in Anchorage occurred when soil liquefied during the earthquake. The subdivision was located on a bluff above Cook Inlet. A section of earth 2,576 m long and 273 m wide broke loose and slid 21 m toward Cook Inlet. At least 75 houses were destroyed. The most probable explanation of the landslide was a loss of strength in underlying soils from the ground shaking. Sand lenses liquefied and clay soils weakened and moved down slope in a complicated motion. Slope failure began 1.5 to 2.0 minutes after the start of the earthquake. Photograph Credit: National Geophysical Data Center.

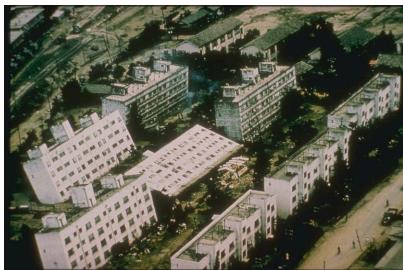
Leaning Apartment Houses in Niigata, Japan Earthquake of June 16, 1964, Niigata, Japan. The magnitude 7.4 earthquake killed 26 and destroyed 3,018 houses and moderately or severely damaged 9,750 in Niigata prefecture.

LIQUEFACTION-DIFFERENTIAL SETTLEMENTS Aerial view of leaning apartment houses in Niigata produced by soil liquefaction and the behavior of poor foundations. Most of the damage was caused by cracking and unequal settlement of the ground such as is shown here. About 1/3 of the city subsided by as much as 2 meters as a result of sand compaction. Photograph Credit: National Geophysical Data Center.

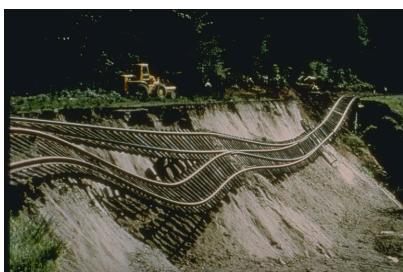
Union Pacific Railway Damage from Ground Deformation, Seattle, Washington Earthquake of April 29, 1965, Seattle, Washington. The magnitude 6.5 earthquake killed 7 and caused 12.5 million in property damage.

GROUND DEFORMATION-LANDSLIDE Damage to the Union Pacific Railway occurred when hillside fill slid away from beneath a 121 m section of the branch line just outside Olympia, more than 60 km from the epicenter. Photograph Credit: University of California, Berkeley.

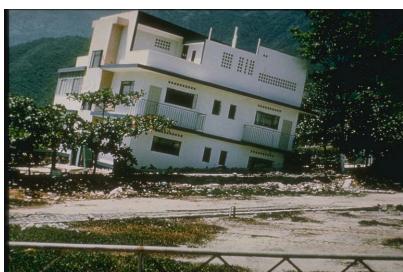
Tipped Residence Due to Differential Settling, Caracas, Venezuela Earthquake of July 29, 1967, Caracas, Venezuela. The magnitude 6.6 earthquake killed 240 and caused \$50 million in property damage.

GROUND DEFORMATION-DIFFERENTIAL SETTLING The ground collapsed beneath this structure in Caracas. A house in foreground has been removed. A number of houses with one or two floors showed great damage in Caracas and in the surrounding area. In addition, a number of high-rise buildings were partially or totally destroyed. This destruction was concentrated in two small areas, one in Caracas and one in Caraballeda, north of Caracas. Soil failures such as the one shown here were blamed for much of the damage. Photograph Credit: National Geophysical Data Center.

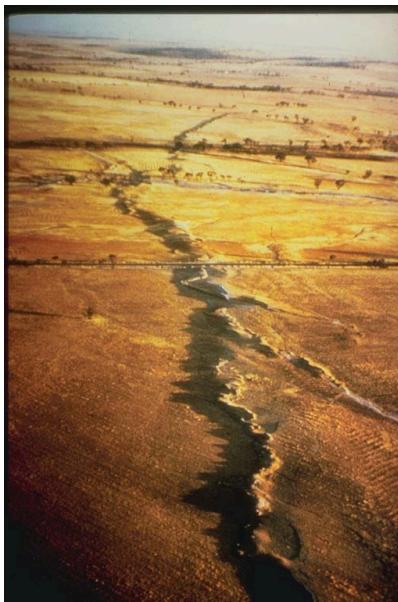
Surface Rupture, Meckering, Australia Earthquake of October 14, 1968, Meckering, Australia. The magnitude 6.8 earthquake caused \$2.2 million in property damage. This earthquake was particularly efficient in the generation of surface waves.

GROUND DEFORMATION-SURFACE RUPTURE Aerial view shows a railroad crossing surface rupture near Meckering. The fresh surface rupture was about 30 km long. Photograph Credit: University of California, Berkeley (Dr. Bruce Bolt).

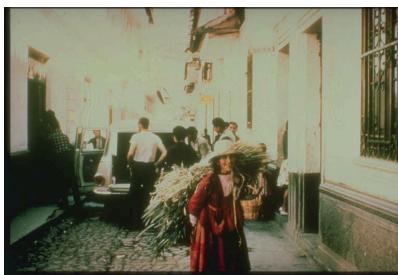
Before View of City Street, Huaraz, Peru Earthquake of May 31, 1970, Huaraz, Peru. The magnitude 7.8 earthquake killed 66,794 and caused \$250 million in property damage. Several towns were almost totally destroyed. This earthquake, with complicating factors of landslides and floods, was one of the largest disasters ever to occur in the Southern Hemisphere.

GROUND SHAKING Photo shows a city street in Huaraz before the earthquake. This adobe construction is typical of much of the housing that underwent complete collapse in the Andean townships. Photograph Credit: University of Colorado.

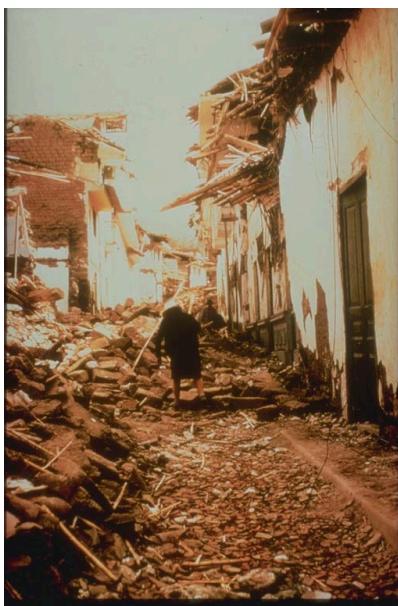
After View of City Street, Huaraz, Peru Earthquake of May 31, 1970, Huaraz, Peru. The magnitude 7.8 earthquake killed 66,794 and caused \$250 million in property damage. Several towns were almost totally destroyed. This earthquake, with complicating factors of landslides and floods, was one of the largest disasters ever to occur in the Southern Hemisphere.

GROUND SHAKING Photo shows a city street in Huaraz after the earthquake. Photograph Credit: University of Colorado.

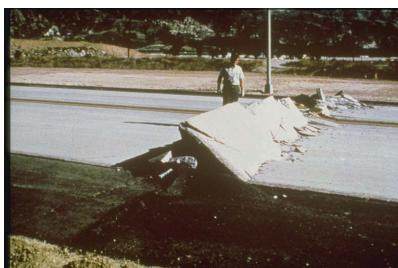
Compression of Freeway, San Fernando, California Earthquake of February 9, 1971, San Fernando, California. The magnitude 6.7 earthquake killed 66 and caused \$0.5-1.0 billion property damage.

SURFACE FAULTING The photograph shows freeway compression of about 69 cm that occurred south of the interchanges of Routes 5/210 near San Fernando. The dip of the fault plane on Freeway 210 was inferred to be 12 degrees. Structural damage to highways and bridges from this earthquake centered in an area north of the city, which included the Route 5/210

Interchange and the Route 5/14 Interchange. Most of the major structural damage to highways was within 10 km of the earthquake epicenter. Photograph Credit: National Geophysical Data Center.

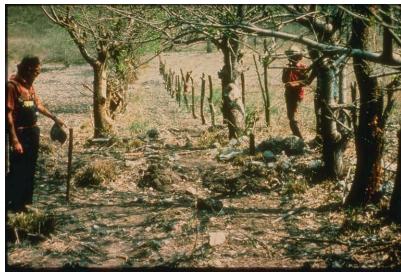
Offset of Trees along Fault, Motagua, Guatemala Earthquake of February 4, 1976, Guatemala. The magnitude 7.5 earthquake killed 23,000, injured 76,000, and caused \$1,100 million in property damage. It was felt over 100,000 square km and was accompanied by extensive surface faulting.

SURFACE FAULTING View southward along a row of trees offset about 3.25 m by strike-slip motion along the Motagua fault in Guatemala. The amount of offset is indicated by the distance between the row of trees on the right and the stake at which the man points. The stake is aligned with the row of trees in the background. Photograph Credit: U.S. Geological Survey.

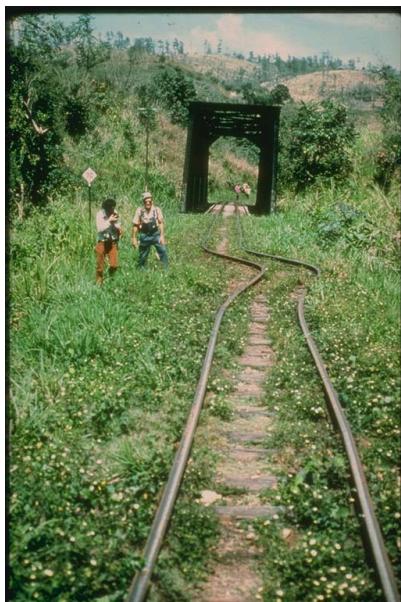
Twisted Railroad Tracks across Fault, Guatemala Earthquake of February 4, 1976, Guatemala. The magnitude 7.5 earthquake killed 23,000, injured 76,000, and caused \$1,100 million in property damage. It was felt over 100,000 square km and was accompanied by extensive surface faulting.

SURFACE FAULTING The view is looking north along railroad tracks that were twisted and offset 1.07 m by the Motagua fault, which is perpendicular to the tracks. This is one of numerous localities at which the main railroad line between the coastal port of Puerto Barrios and Guatemala City was disrupted by the faulting. Photograph Credit: U.S. Geological Survey.

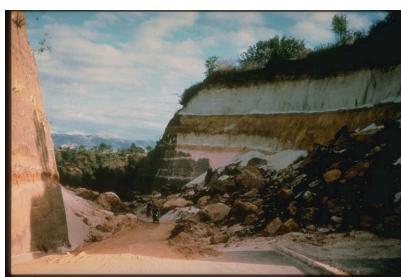
Landslide near Guatemala City, Guatemala Earthquake of February 4, 1976, Guatemala. The magnitude 7.5 earthquake killed 23,000, injured 76,000, and caused \$1,100 million in property damage. It was felt over 100,000 square km and was accompanied by extensive surface faulting.

LANDSLIDES Landslides occurred in the steep roadcut of stratified pumice and ash deposits at the San Cristobal subdivision west of Guatemala City. The materials exposed in this roadcut are typical of much of the Pleistocene tephra deposits that underlie inhabited parts of the Guatemalan highlands. Photograph Credit: U.S. Geological Survey.

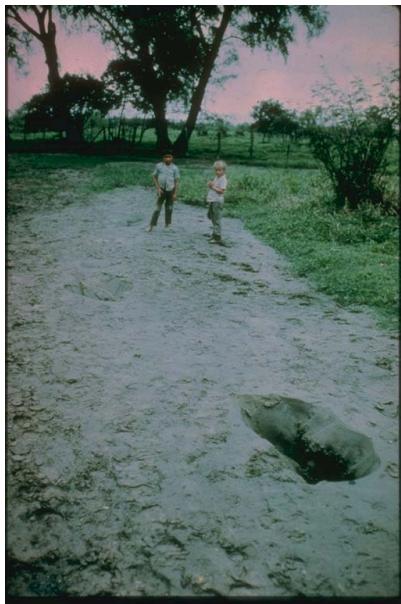
Liquefaction, Motagua Valley, Guatemala Earthquake of February 4, 1976, Guatemala. The magnitude 7.5 earthquake killed 23,000, injured 76,000, and caused \$1,100 million in property damage. It was felt over 100,000 square km and was accompanied by extensive surface faulting.

LIQUEFACTION Sand mounds deposited by spouting from the row of crater-like vents in the lower Motagua Valley, Guatemala. Increased pressure due to the earthquake forced the liquefied sands to the surface. Photograph Credit: U.S. Geological Survey.

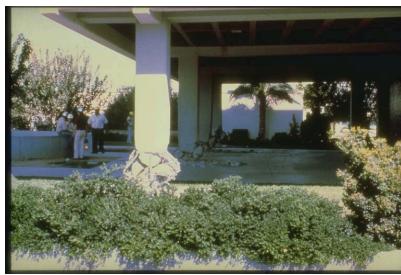
Support Pillar Failure, Imperial County Services Building, El Centro Earthquake of October 15, 1979, El Centro, California. The magnitude 6.9 earthquake caused \$30 million property damage and injured 91 people.

GROUND SHAKING The support pillar failed at the east end of the Imperial County Services Building in El Centro. This 6-story reinforced concrete frame and shear wall structure completed in 1971 at a construction cost of \$1.87 million, was designed to be earthquake resistant. The concrete at the base of the columns was shattered and the vertical reinforced bars were severely bent, allowing the building to sag about 30 cm. The building was later destroyed and rebuilt. Photograph Credit: U.S. Geological Survey.

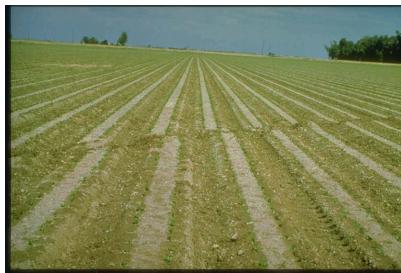
Offset of Lettuce Rows across Fault, El Centro, California Earthquake of October 15, 1979, El Centro, California. The magnitude 6.9 earthquake caused \$30 million property damage and injured 91 people.

SURFACE FAULTING Here earthquake faulting has caused an offset of rows in a lettuce field near El Centro. Such a fault with purely horizontal displacement to the right as one looks across the fault is known as a right lateral strike slip fault. The agriculture industry suffered heavy losses due to damage to canals, irrigation ditches, and subsurface drain tiles disturbed by the movement along the Imperial Fault. Photograph Credit: University of Colorado.

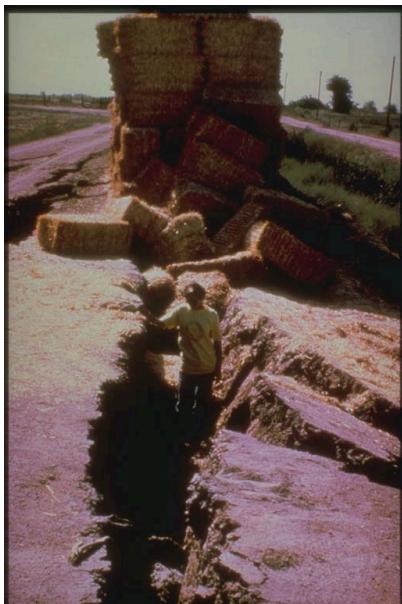
Slumping near El Centro, California Earthquake of October 15, 1979, El Centro, California. The magnitude 6.9 earthquake caused \$30 million property damage and injured 91 people.

GROUND DEFORMATION-SLUMPING This slumping resulted from the earth shaking near El Centro. The earthquake produced extensive lateral slope failure along many irrigation canals. Photograph Credit: University of Colorado.

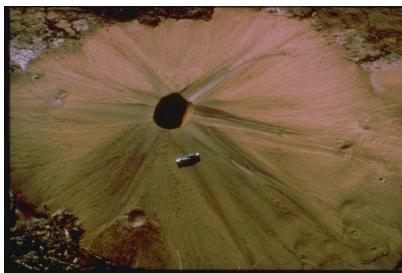
Sand Boil produced by Liquefaction, El Centro, California Earthquake of October 15, 1979, El Centro, California. The magnitude 6.9 earthquake caused \$30 million property damage and injured 91 people.

LIQUEFACTION The photo shows one of many sand boils that formed near El Centro. At localities where the water table is close to the surface, compaction of saturated unconsolidated materials is often accompanied by ejection of water or water-sediment mixtures forming sand boils. Photograph Credit: University of Colorado.

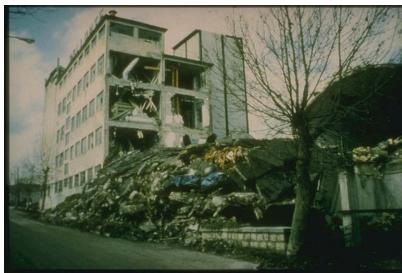
Collapsed Unit of Pallante Factory, Campania, Italy Earthquake of November 23, 1980, Campania, Italy. The magnitude 6.8 earthquake killed over 3,000, injured 7,750, and caused severe property damage. An additional 1,575 were reported missing and presumed dead. Two hundred fifty thousand were reported to be homeless. Twenty five thousand square kilometers of southern Italy were devastated.

GROUND SHAKING Collapsed unit of the Pallante factory at Campania, caused by failure at a construction joint. Some infill walls of the remaining structure have also failed. The large death toll from a magnitude 6.9 earthquake resulted from poor construction practices such as the infill masonry wall shown here. Photograph Credit: National Academy Press.
