Geologic Hazards Photos Volume 1

The Behavior of Columns

General Information About Columns

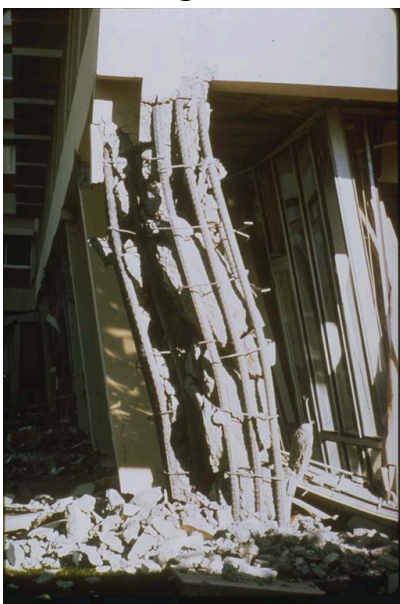
Sometimes the configuration of the building causes the columns to be over stressed, and when they fail, the building fails. This was the case with the Olive View Hospital, which was severely damaged in the 1971 San Fernando California earthquake. The first two floors were soft stories in which the principal support for the floors above were columns. When earthquake shaking caused the upper floors to move as a unit as much as two and a half feet, the first and second floor columns could not accommodate such a large displacement, and they failed [No. 1]. The result was that the entire building had to be demolished.

First-story column failure, San Fernando, CA Close-up of first-story column failure at Olive View Hospital, damaged in the San Fernando (California) earthquake of 1971. The column was located at the west end of Wing B on the first story of the five-story hospital. This is a typical first-story tied corner column, and the damage is characteristic of column damage found on the first floor in all wings of the hospital. These corner columns were square with a corner notch out, giving the appearance of a thick L-shaped column. Note the broken ties, the spacing of the ties, and the bent rebar. The building was laterally displaced about two feet to the north in the earthquake. [Photo credit: E.V. Leyendecker, U.S. Geological Survey.]

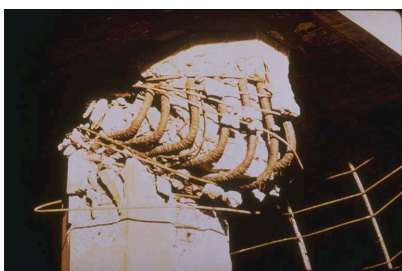
Spirally wrapped column failure on interstate, California Failure of a spirally wrapped column at the intersection of Interstate 5 and Interstate 210 caused by the San Fernando earthquake of 1971. The column failure possibly resulted from dropping of the overpass on top of the lower bridge. [Photo credit: E.V. Leyendecker, U.S. Geological Survey.]

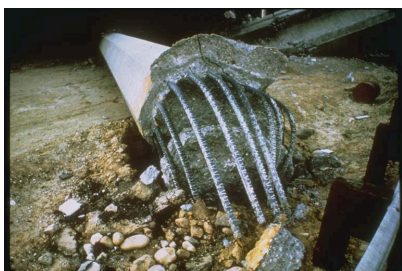
Collapsed column, Interstate 5/210 interchange, California This failed column was a part of the collapsed Interstate 5/210 interchange-a 7-span, non-prestressed, reinforced concrete box girder structure, that completely collapsed in the San Fernando earthquake of 1971. The structure was carried on single column bents. The base of the column pulled out of the 6-foot diameter cast-in-place drilled shaft. At failure some hoops separated and pulled out. [Photo credit: E.V. Leyendecker, U.S. Geological Survey.]

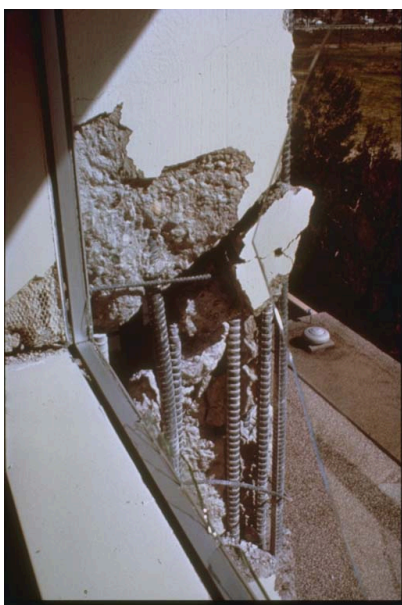
Column failure, Holy Cross Hospital Column failure at the Holy Cross Hospital during the San Fernando earthquake of 1971. The concrete in the southeast corner fourth-story exterior column was crushed. Note the splice of the column steel and the widely spaced ties. [Photo credit: E.V. Leyendecker, U.S. Geological Survey.]

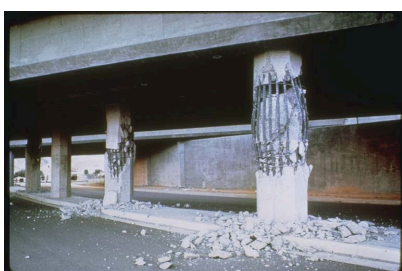
Failure of several columns, Foothills Freeway overpass Column failure at an overpass (Foothills Freeway crossing Foothills Boulevard) as a result of the San Fernando earthquake of 1971. This slide shows failures of three of the spirally-wrapped columns that provided the central support of this overpass. The third column shows relatively minor damage. Failures may have resulted from a combination of vertical and horizontal acceleration. It appears that the bridge deck may have rotated due to the ground motion. [Photo credit: E. V. Leyendecker, U.S. Geological Survey.]

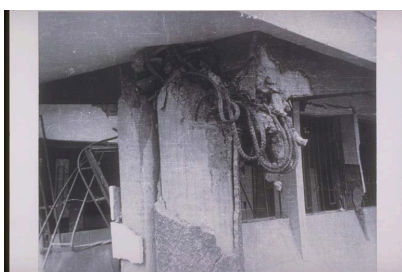
Spirally-wrapped column failure, Ecuador Failure of a spirally-wrapped column at the Juan Montalvo School in Esmeraldas, Ecuador, due to the 1976 earthquake. Note that the column appears to have been shortened and moved laterally. [Photo credit: J. R. Silva.]

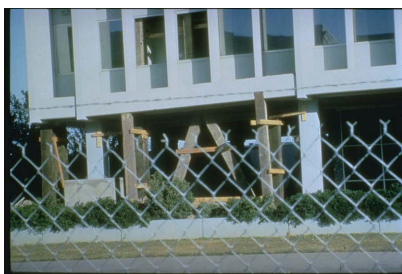
Another building configuration that resulted in column failure is shown in photos 7 and 8, the Imperial County Services Building. During the 1979 El Centro, California, earthquake, the building was destroyed due to column shortening by compression at the east end of the building.

Imperial County Services Building after 1979 earthquake View of the Imperial County Services Building after the 1979 El Centro (California) earthquake. Support framework is visible. This six-story reinforced concrete frame and shear wall structure was built in 1969 at a construction cost of \$1.87 million, and was designed to be earthquake resistant. However, during the quake, the concrete at the base of the support columns was shattered, and the vertically reinforced bars were severely bent allowing the east portion of the building to sag about 30 cm. The extra load on the columns at the east end of the building came from the discontinuous shear wall at this end of the building. Rotational forces were not dissipated by the shear wall causing a compressional load on the columns. The building had to be replaced at an estimated cost of seven million dollars. [Photo credit: G. Reagor, U.S. Geological Survey.]

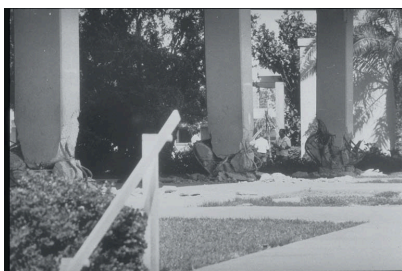
Damaged columns, Imperial County Services Building Close-up view of the collapsed columns of the Imperial County Services Building, El Centro. The columns failed as a result of the discontinuous shear wall on the east end of the building. The shear wall effectively stopped at the bottom of the second floor increasing the load on the columns at that end of the building. [Photo credit: C. Reed, California Geology.]

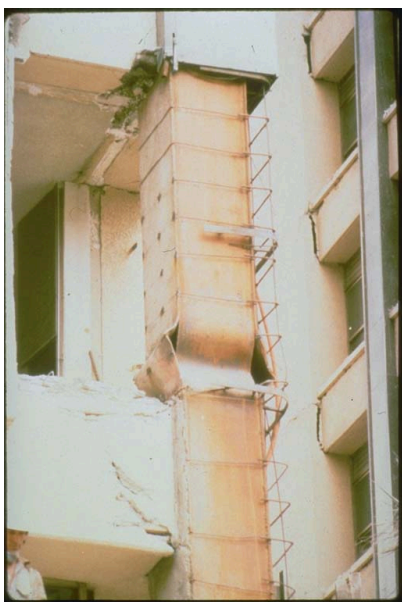
Buckled box column, Mexico City Buckled box column on the south side of center 23-story tower, one of five towers at the Pino Suarez Complex damaged in the 1985 Mexico City earthquake. The columns were hollow box sections made of four plates with exterior welds along the edges. Internal stiffener plates were spaced at regular intervals and welded to three sides along the interior length and along all four sides at the column ends. The structure was designed as a moment-resisting frame, and not much inelastic deformation developed in the beams. Local plate buckling-amplified by weld tears at the plate joints-occurred in the most highly stressed columns along the south face near the top of the common mezzanine. Buckling of columns, and deformations caused by other actions, produced tilt of the structure towards the south. [Photo credit: E.V. Leyendecker, U.S. Geological Survey.]

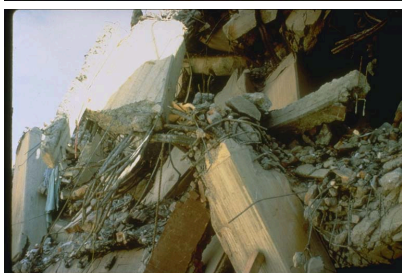
Close-up of failed member of Juarez Hospital Close-up joint details of the Juarez Hospital that collapsed during the 1985 Mexico City earthquake. The failure indicates lack of sufficient confining reinforcement in the vicinity of the joint. This nine-story reinforced concrete-frame structure collapsed towards the east exhibiting localized failures at the beam-to-column joints of each floor. This is an example of weak column/strong beam construction. The floors were relatively unaffected by the shaking and were damaged only when the columns totally failed. This close-up of various joints indicates that the columns were generally well-proportioned to resist gravity loads. However, there was minimal-to-nonexistent confinement through the joints. Furthermore, many joints had longitudinal bar splices at these same critical moment locations. The lack of confinement, and the presence of splices lead to a loss of vertical load-bearing capacity as soon as the bond strength was lost and directly contributed to the failure of the entire structure. The Juarez Hospital collapsed and 400 medical personnel and patients, notably infants, were trapped in the maternity wing. Rescue personnel continued to retrieve survivors as late as ten days after

the earthquake by tunneling through the debris between the floor slabs. [Photo credit: E.V. Leyendecker, U.S. Geological Survey.]

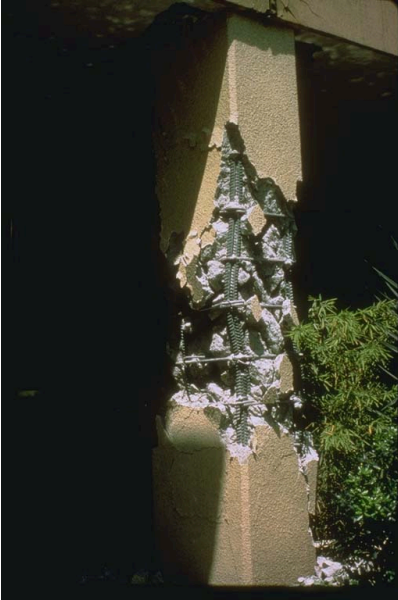
Failed first-story column, Mexico City Failed first-story column in an eleven-story apartment building after the 1985 Mexico City earthquake. This column failure was induced by a variation in stiffness between the first and other floors of the building, concentrating the load in the first story columns. Note that column ties appear to be undamaged. [Photo credit: E.V. Leyendecker, U.S. Geological Survey.]

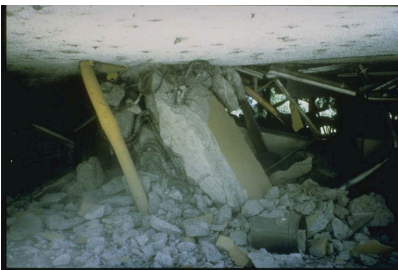
Porch column tipped when house shifted on foundation Close-up view of completely shattered and collapsed first-story columns under the Economics and Science Building at the National University in San Salvador. The damage occurred during the 1986 earthquake in El Salvador. [Photo credit: R.W. Anderson, Earthquake Spectra, Earthquake Engineering Research Institute.]

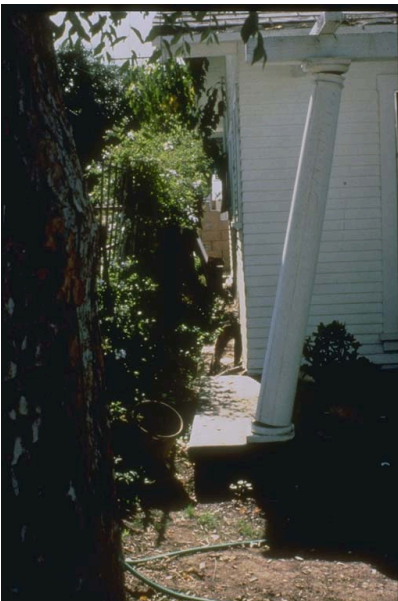
Shattered columns under Economics Building, San Salvador The 1987 Whittier (California) earthquake caused many houses to shift on their foundations. This house at 13312 Beverly Boulevard between Painter Avenue and Friends Street has shifted at least a foot on its foundation. The shifting has caused the wooden column to be tipped off its base. Further shifting would have resulted in a column and porch collapse. [Photo credit: G. Reagor, U.S. Geological Survey.]

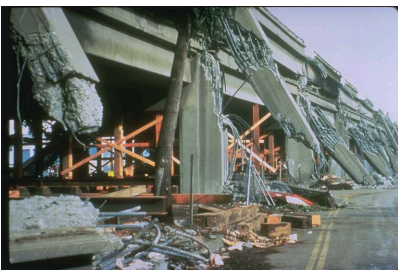
Collapsed Cypress section of Interstate 880 Side view of the Cypress section of Interstate 880 which collapsed as a result of the 1989 Loma Prieta (California) earthquake. Note the failed column support (buttress) in the center of the photo. The upper deck of the double deck structure dropped almost vertically onto the lower deck along a one-mile section of the freeway. Columns supporting the upper deck were thrown transverse to the longitudinal axis of the roadway. Some columns sheared off at the hinge at the bottom of the upper column; some remained attached to the upper deck. Other columns were found completely intact on the ground. Fifty-one spans of this structure were involved

in the collapse which killed forty-one motorists. [Photo credit: Wilshire, U.S. Geological Survey.]

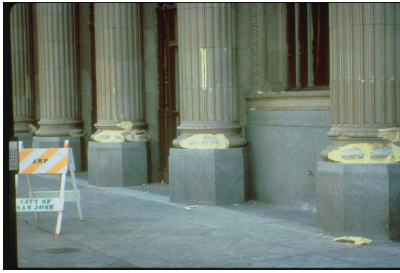
Bases chipped when columns tipped during Loma Prieta earthquake

Cosmetic damage to columns caused by the 1989 Loma Prieta earthquake. Pedestals were chipped when the columns tipped on the Old Bank of America Building at North First and Santa Clara Street in San Jose. A greater distance between floors at the ground story than in upper stories results in greater vulnerability to earthquake damage in that story. There is a significant discontinuity of strength and stiffness between the vertical structure of the first floor and the remainder of the structure. [Photo credit: C. Stover, U.S. Geological Survey.]

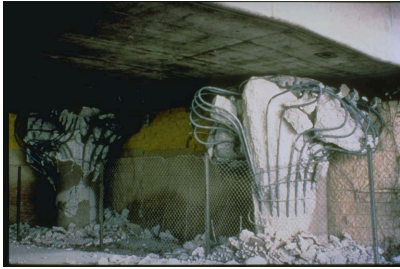
Overpass columns damaged in Northridge earthquake Columns supporting the Highway 10 overpass at Venice Boulevard were damaged in the Northridge (California) earthquake of 1994. There was insufficient shear reinforcement, leading to lack of the necessary column confinement. The columns were spirally wrapped. [Photo credit: M. Celebi, U.S. Geological Survey.]

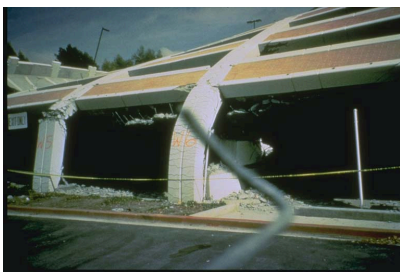
Parking garage columns damaged in Northridge earthquake Parking garage at California State University in Northridge damaged in the 1994 earthquake. The garage was of precast, post-tensioned construction and was built in 1991. The center columns were crushed, resulting in caving-in of the floors and extreme bending of the external columns. No cars were in the structure at the time of the earthquake. A nearby shear wall was essentially undamaged. [Photo credit: M. Celebi, U.S. Geological Survey.]

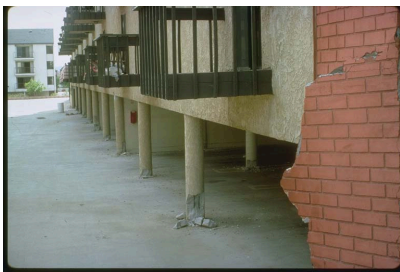
Splayed column bases, Northridge earthquake A splaying of support columns near their bases due to earthquake-induced motions of the upper stories in an apartment building in Northridge. The apartment was located on Meridy Street near Zelzah Street. The first story of the building was relatively open with few partitions; the second floor was supported by columns. This common configuration is known as a "soft story." This condition creates a discontinuous load path resulting in an abrupt change of strength and stiffness at the point of change. [Photo credit: J. Dewey, U.S. Geological Survey.]

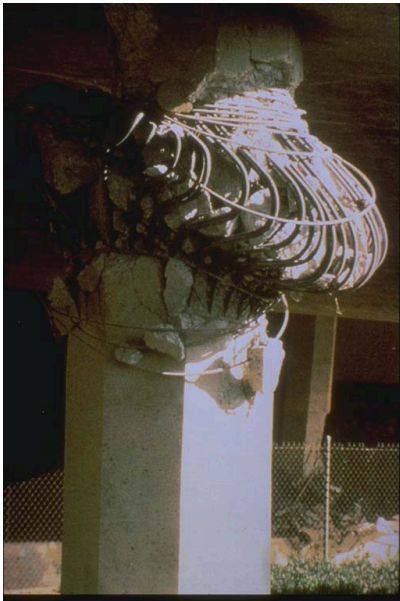
Failed bridge support, Northridge earthquake Bridge column supporting Interstate 10 (Santa Monica Freeway) at the La Cienega-Venice overcrossing failed in the 1994 Northridge earthquake. [Photo credit: M. Celebi, U.S. Geological Survey.]

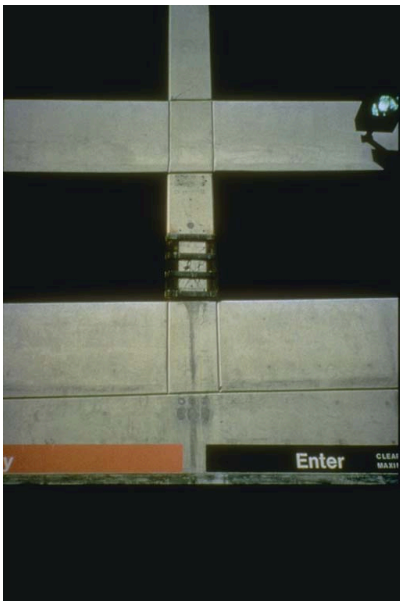
"Short column" effect, Northridge earthquake Reinforced concrete garage building off Ventura Boulevard at the intersection of Highway 405. Damage was caused by the 1994 Northridge earthquake. Although the building appears to have shear walls, several columns were damaged. The columns were made more vulnerable to damage when their spans were shortened by the balcony parapets. This is known as the "short column" effect. When columns are shortened, the effect is to make them less ductile. An attempt has been made to repair the column by putting a partial jacket around it. [Photo credit: M. Celebi, U.S. Geological Survey].
