## Geologic Hazards Photos Volume 2

#### The Loma Prieta Earthquake, October 1989 Part 2: Effects in San Francisco and Oakland

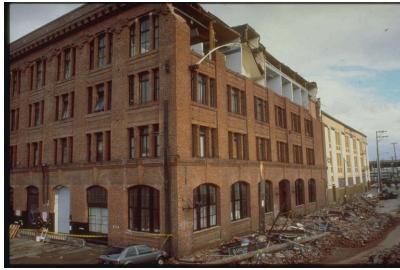
**Collapsed 4th-Story Wall, San Francisco, California** The fourth-story wall of this unreinforced masonry building on Bluxome Street near Sixth and Townsend collapsed onto the street, crushing five people in their cars. No one in the building was killed. [Photo credit: E.V. Leyendecker, U.S. Geological Survey.]

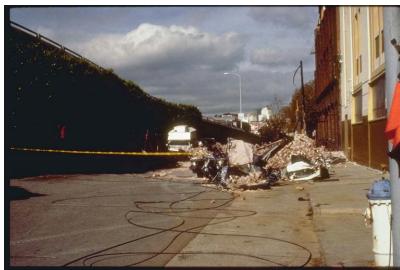
**Damaged Cars in which 5 People Were Killed, San Francisco, California** Detail of damage to cars in which five people were killed by parapet collapse of the four-story building on Bluxome Street. The 6th Street freeway on-ramp is visible on the left of the photo. This building is located in an area south of Market Street that had a number of damaged buildings. An eight story building in the same area was damaged severely and had to be demolished. [Photo credit: D. Perkins, U.S. Geological Survey.]

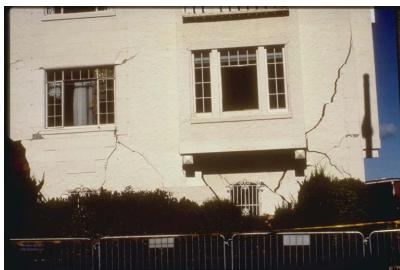
**Cracks in Building, Marina District, San Francisco** These cracks in a building along Jefferson Street in the Marina District of San Francisco are typical of the damage in that area. One hundred eighty-five buildings were structurally damaged in the area. [Photo credit: D. Perkins, U.S. Geological Survey.]

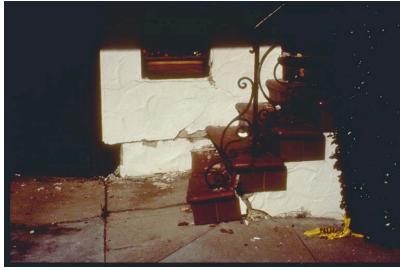
**House Shifted on Foundation, Marina District, San Francisco** This house along Jefferson Street in the Marina District shifted more than 10 cm on its foundation. Houses that were not bolted to their foundations were particularly vulnerable to damage. [Photo credit: D. Perkins, U.S. Geological Survey.]

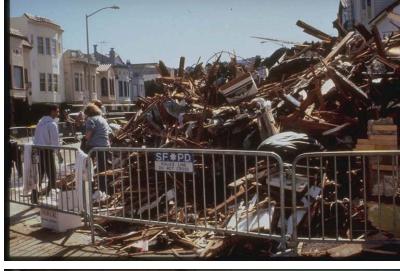
**Collapsed Building, San Francisco** This collapsed and demolished building along Jefferson Street is typical of the 35 buildings that were eventually torn down. Note buildings that remain standing at left and at right top. [Photo credit: D. Perkins, U.S. Geological Survey.]

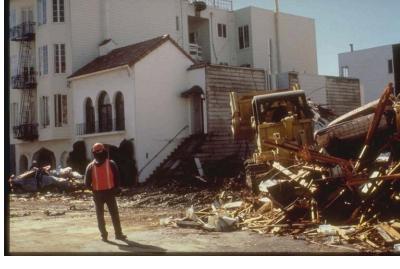
**Demolition of Collapsed Building, San Francisco** Demolition of above building on Jefferson Street. View is taken around the corner from location of previous photograph. Note damage to the remaining building with an open first floor. [Photo credit: D. Perkins, U.S. Geological Survey.]

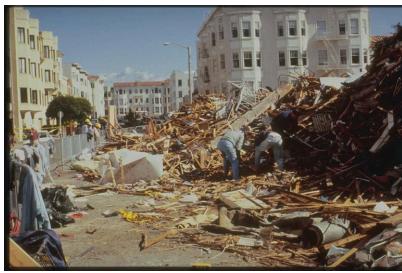
**View of Damage along Jefferson Street, San Francisco** Another view along Jefferson Street in the Marina District. Tenants try to salvage items from the rubble. [Photo credit: D. Perkins, U.S. Geological Survey.]

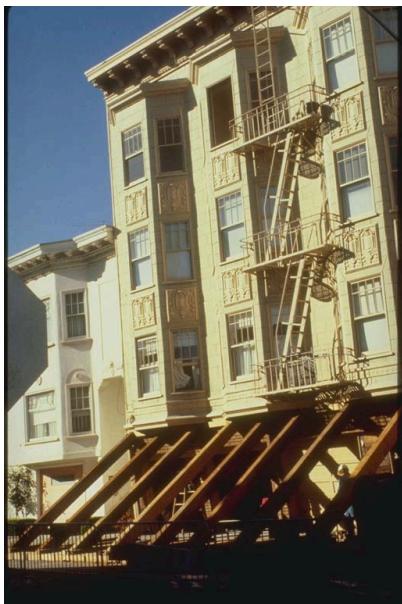
**Shored Building in the Marina District, San Francisco** Shored building on Beach Street in the Marina District. Note the garage area on the first floor beneath the apartments. This common construction practice weakened the first floors of the structures. [Photo credit: D. Perkins, U.S. Geological Survey.]

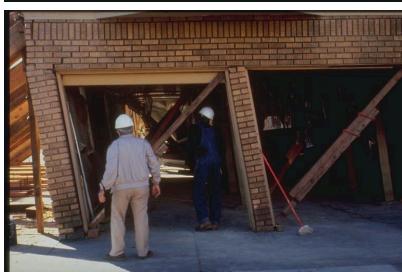
**Detail of Shoring to Garage, Marina District, San Francisco** Detail of shoring to garage area in building on Beach Street in the Marina District. The practice of using the first floor for garages left the building with inadequate lateral bracing on the ground level. [Photo credit: D. Perkins, U.S. Geological Survey.]

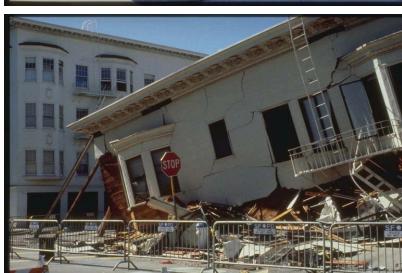
**Collapsed Building in the Marina District, San Francisco** A collapsed building in the Marina District. The first story of this three story structure failed when ground shaking was intensified by liquefaction. The second story collapsed, leaving only the third story. [Photo credit: D. Perkins, U.S. Geological Survey.]

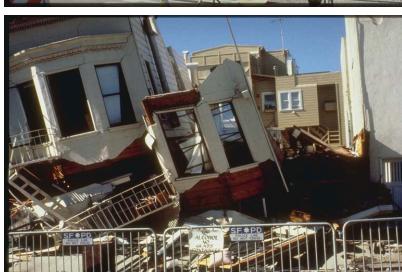
**Collapsed Building, Marina District, 2nd View** A second view of the collapsed building shown in the previous slide. Nine people were killed in the Marina District as a result of the fires and the building collapses. [Photo credit: D. Perkins, U.S. Geological Survey.]

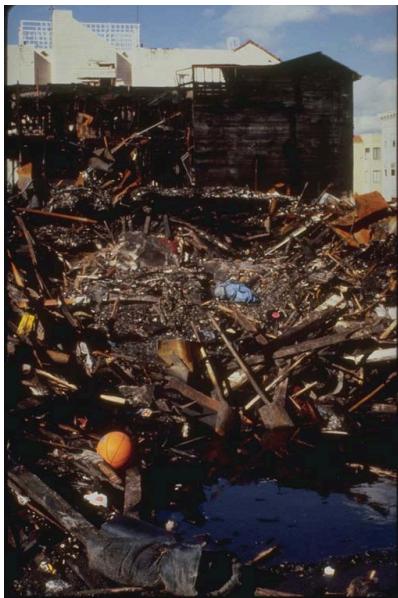
**Rubble Left after Fire in Marina District** Rubble after the fire at North Point Street and Divisadero in the Marina District. As in 1906, water mains failed and fires in this area could not be fought with city water. Water was pumped from a fireboat to extinguish this fire. [Photo credit: D. Perkins, U.S. Geological Survey.]

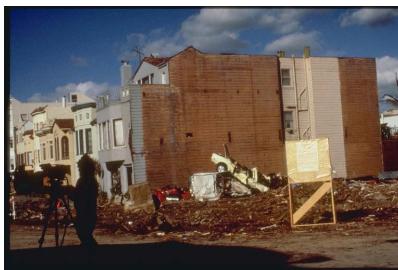
**Demolished Cars and Rubble, Marina District** Demolished cars and rubble. This view is looking east across the street from a fire at North Point and Divisadero in the Marina District. [Photo credit: D. Perkins, U.S. Geological Survey.]

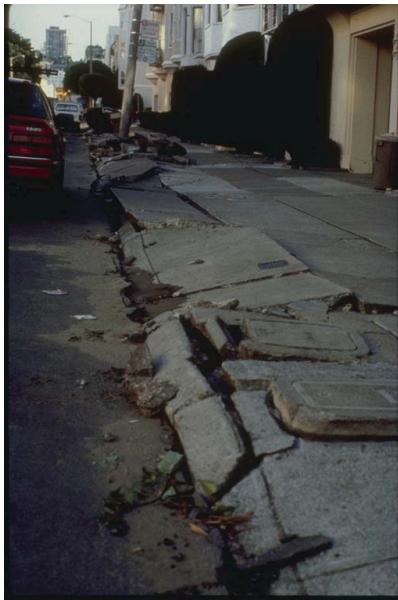
**Sidewalk Damage Produced by Liquefaction, Marina District, San Francisco** View south on Webster Street in the Marina District. Sidewalk damage is the result of liquefaction of the land fill upon which the area was built. Note the upheaved section in the background near the pole. The manmade fill beneath the Marina District was permanently deformed by liquefaction. Structures resting on the fill had to accommodate the deformation. [Photo credit: D. Perkins, U.S. Geological Survey.]

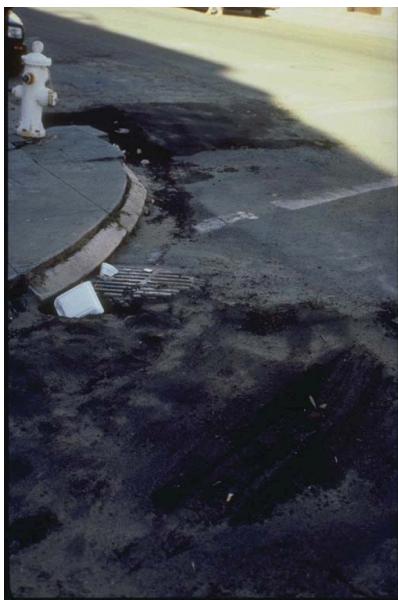
**Evidence of Liquefaction in the Marina District, San Francisco** The fine sand deposited near the curb is evidence of the liquefaction that took place in the Marina District. Some sand boils in the area spewed forth charred wood and other debris, remnants of the San Francisco that was destroyed by earthquake and fire in 1906. [Photo credit: D. Perkins, U.S. Geological Survey.]

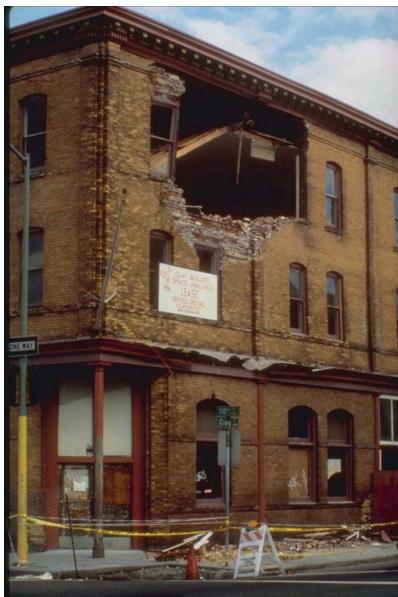
**Damage to Top Floor of Clay Building, Oakland, California** Damage to the upper floor of the three-story Clay Building at the corner of 10th and Clay Streets in Oakland, California. [Photo credit: C. Stover, U.S. Geological Survey.]

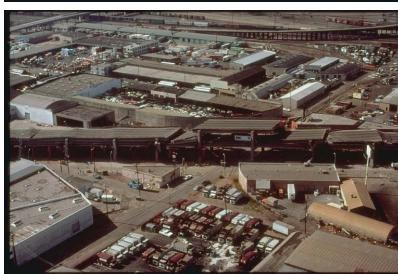
**Aerial View of Collapsed Interstate 880, Oakland, California** Aerial view looking west at the collapsed Interstate 880 double-decked highway structure. Fifty-one spans of this structure were involved in the collapse which killed 41 motorists. Only one 1.2 km span, shown in the center of the photo, did not collapse. [Photo credit: E.V. Leyendecker, U.S. Geological Survey.]

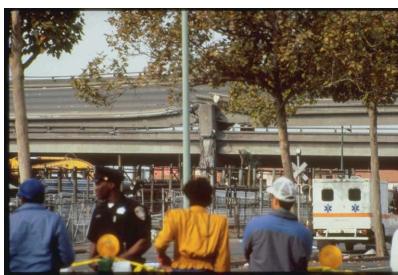
**Side View of the Collapsed Section of Interstate 880, Oakland, California** Side view of the collapsed Cypress section of the Interstate 880. Note the failed column support in the center of the photo and the ambulance to remove survivors. [Photo credit: C. Stover, U.S. Geological Survey.]

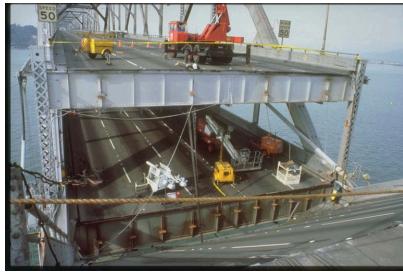
**View of Damage to San Francisco Oakland Bay Bridge** View of the San Francisco-Oakland Bay Bridge looking west showing the failed 15-m long section at Pier E-9. The view is looking west from the upper deck of the 88-m truss (beam) supported by Pier E-9. A 153-m-long truss, also supported at Pier E-9, is shown on the west side of the opening. The 15-m span of the upper deck was supported at the west end by bearings attached to the large north-south girder visible on the west side of the opening. These support bearings allowed expansion movement of the 15-m sections. Similar supports were provided on a girder at the east side of the opening, except the bearings were attached to prevent movement. Failure of the bearings of the 88-m (east) truss allowed movement toward the east. This pulled the 15-m sections (upper and lower), which were attached to it, off their expansion bearings on the west end. The spans then collapsed but remained partially attached at the east end. [Photo credit: E.V. Leyendecker, U.S. Geological Survey.]

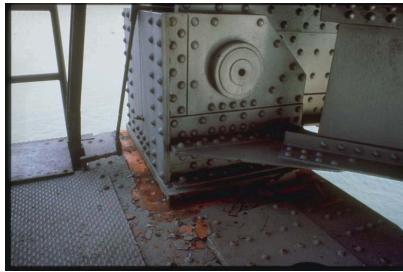
**Damage to Truss Support Bearing Shoe, San Francisco Oakland Bay Bridge** Truss support bearing shoe at Pier E-9 of the San Francisco-Oakland Bay bridge. This bearing shoe was located at the northeast corner of Pier E-9 and supported the northwest corner of the 88-m truss shown in photo 16. An identical bearing shoe was located in the southeast corner. Together, these bearings provided support for the 88-m truss at Pier E-9. Each bearing shoe was attached to Pier E-9 with 20 2.54 cm diameter bolts. During the earthquake all of the bolts in both bearing shoes failed. This allowed movement of the previously attached 88-m truss. As evidenced by the exposed paint, the bearing shoe came to rest about 14 cm to the north and 1.58 cm to the east of its original position. [Photo credit: E.V. Leyendecker, U.S. Geological Survey.]
