Geologic Hazards Photos Volume 2

Earthquake Events

Earthquakes in Southern California, 1979-1989

Slide Set Images

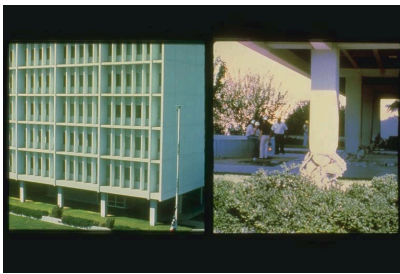
Imperial County Services Building Before and After 1979 Earthquake Left: Imperial County Services Building (El Centro) before the earthquake. Right: After the earthquake. There is support pillar failure at the east end of building. This 6-story reinforced concrete frame and shear wall structure was completed in 1971 at a construction cost of \$1.87 million. It was designed to be earthquake resistant. However, during the quake the concrete at the base of the support columns shattered and the vertical reinforced bars were severely bent, allowing the east portion of the building to sag about 30 cm. Replacement costs were estimated at \$7 million. [Photo credits: Bay Area Regional Earthquake Preparedness Project and U.S. Geological Survey.]

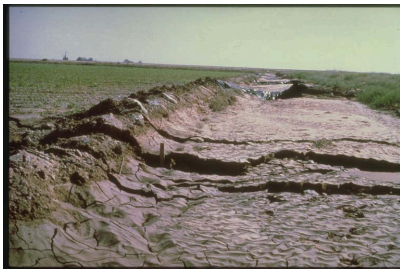
Earth Cracks near El Centro from 1979 Earthquake Earthquake of October 15, 1979, Imperial Valley, California. Earth cracks near El Centro, California. Such cracks caused the breakage of underground water pipes in many places. However, utilities were interrupted for only a short period of time. [Photo credit: University of Colorado.]

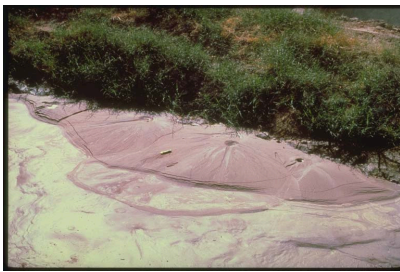
Sand Boil Near El Centro, 1979 Earthquake of October 15, 1979, Imperial Valley, California. A sand boil near El Centro provides graphic evidence of liquefaction. Such boils were found along the southern extent of the Imperial Fault. Liquefaction occurs when earthquake ground shaking distorts the granular structure of the ground causing some loosely packed groups of grains to collapse together. Each collapse transfers pressure from the grain groups to the water. When the pore-water pressures reach a critical level, the granular material suddenly behaves as a liquid rather than a solid. Liquefaction has taken place. [Photo credit: G. Reagor, U.S. Geological Survey.]

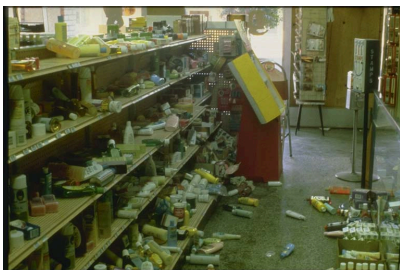
Merchandise on Floor After 1979 Imperial Valley Earthquake Earthquake of October 15, 1979, Imperial Valley, California. Merchandise that fell from shelves in Brawley Drug Store. Aftershocks continued for several months. Several shocks were strong enough to knock merchandise from shelves and to break display windows in the area. [Photo credit: G. Reagor, U.S. Geological Survey.]

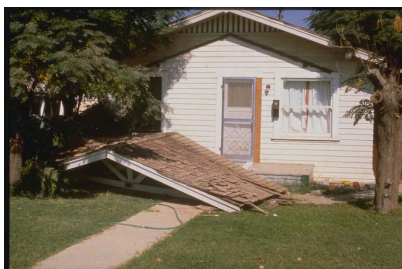
Fallen Porch after 1979 Imperial Valley Earthquake Earthquake of October 15, 1979, Imperial Valley, California. Fallen porch on 200 block of "G" Street in Brawley. Several homes were damaged in this block. Most of the residential damage was to chimneys. [Photo credit: G. Reagor, U.S. Geological Survey.]

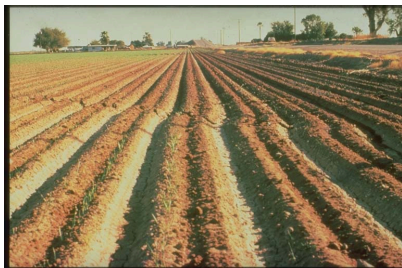
Fault Trace across Lettuce Field, 1979 Imperial Valley Earthquake Earthquake of October 15, 1979, Imperial Valley, California. A fault trace crosses a cultivated field near El Centro. The surface rupture on the Imperial Fault extended from about 2.5 miles (4 km) north of the International Border to about 2.5 miles south of Brawley. Maximum lateral displacement was about 22 inches (55 cm) at Heer Dunes and the maximum vertical displacement was 7.5 inches (19 cm) southeast of Brawley. [Photo credit: University of Colorado.]

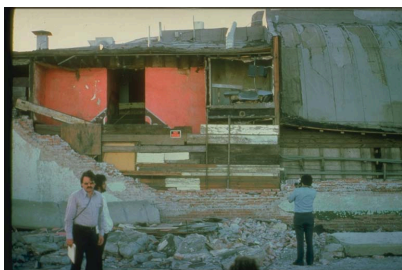
Damage to Theater at Brawley, 1979 Imperial Valley Earthquake Earthquake of October 15, 1979, Imperial Valley, California. The unreinforced brick wall at the Brawley Theater collapsed. Most of the building damage in the business district of Brawley occurred between the 500 and 900 blocks. Unreinforced brick structures are particularly vulnerable to earth shaking. [Photo credit: Bay Area Regional Earthquake Preparedness Project.]

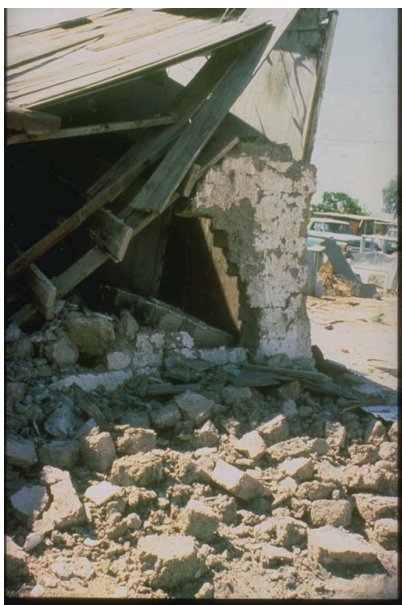
Damage to Adobe Building in Westmorland, CA, 1981 Earthquake of April 26, 1981, Westmorland, California. View of a partially collapsed adobe building in Westmorland. Seventy percent of the 900 homes in Westmoreland were damaged. Most, like this structure, were constructed of adobe and/or brick. [Photo credit: Bay Area Regional Earthquake Preparedness Project.]

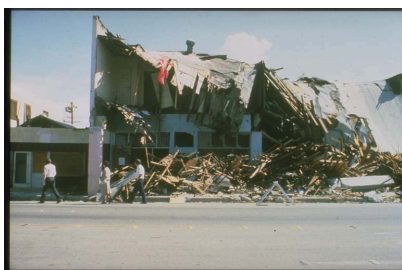
Collapsed Building in 1981 Westmorland, CA Earthquake Earthquake of April 26, 1981, Westmorland, California. View of a two-story building which partially collapsed in the earthquake. Note the undamaged one story building on the left. Twelve buildings were severely damaged and an additional thirty sustained minor damage. City officials ordered the demolition of ten downtown buildings that were damaged beyond repair. [Photo credit: Bay Area Regional Earthquake Preparedness Project.]

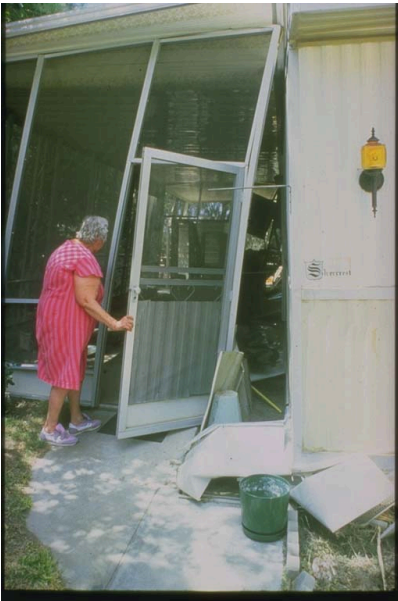
Porch Damage, 1986 Palm Springs, CA Earthquake Earthquake of July 8, 1986, Palm Springs, California. This porch was separated from the trailer and damaged by the quake. Trailers incurred more structural damage than any other type of structure in this earthquake. [Photo credit: Bay Area Regional Earthquake Preparedness Project.]

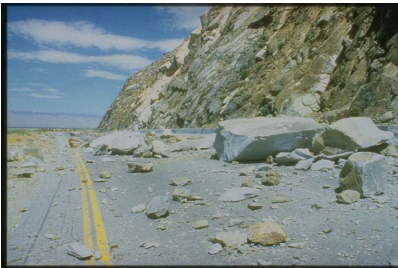
Rockfall on Highway after 1986 Palm Springs Earthquake Earthquake of July 8, 1986, Palm Springs, California. This rockfall on the highway is just one of many landslides that occurred in the Palm Springs, California, area. Such rockfalls can temporarily block roads and highways and hinder the movement of emergency vehicles. [Photo credit: Bay Area Regional Earthquake Preparedness Project.]

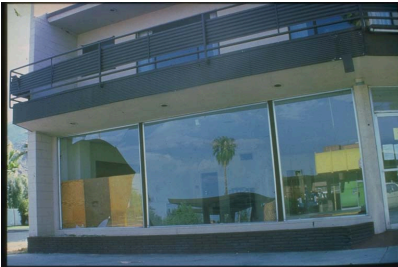
Damage to Display Window, 1986 Palm Springs Earthquake Earthquake of July 8, 1986, Palm Springs, California. A broken display window in downtown Palm Springs. Display windows often break in moderate magnitude earthquakes since the window occupies a large, structurally-unsupported area of the building subject to torsional forces. [Photo credit: Bay Area Regional Earthquake Preparedness Project.]

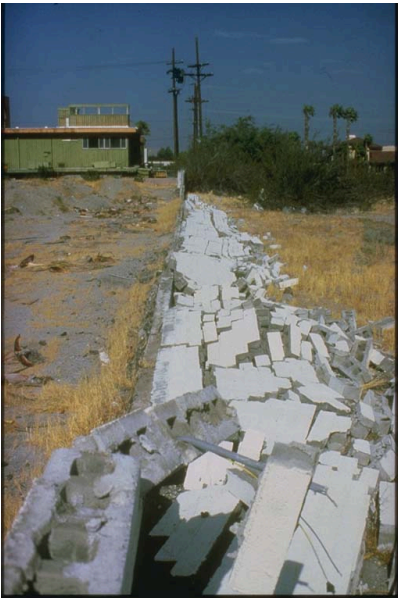
Collapsed Concrete Block Fence Due to 1986 Palm Springs, CA Earthquake Earthquake of July 8, 1986, Palm Springs, California. This concrete block fence near a trailer park collapsed during the quake. Such fence failures were common. Note bent reinforcing rod. [Photo credit: Bay Area Regional Earthquake Preparedness Project.]

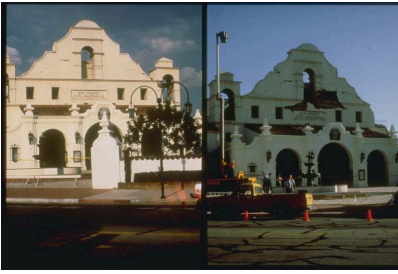
Two Views of Auditorium Showing Damage of 1987 Whittier, CA

Earthquake Earthquake of October 1, 1987, Whittier Narrows, California. Left: San Gabriel Civic Auditorium after the main shock and before the large aftershock. Note cracks near the bell tower. Right: The same structure showing damage that occurred during the large aftershock. The bell tower that was weakened by the main shock has fallen, and the exterior of building is damaged. [Photo credit: G. Reagor, U.S. Geological Survey.]

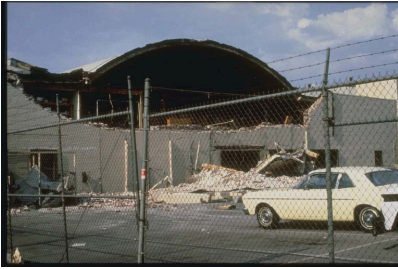
Partial Collapse of Store in 1987 Whittier, CA Earthquake Earthquake of October 1, 1987, Whittier Narrows, California. Partial collapse of the back wall of a thrift store located on Main Street between Fifth and Sixth Streets in Alhambra. Falling bricks crushed cars parked in the street. [Photo credit: G. Reagor, U.S. Geological Survey.]

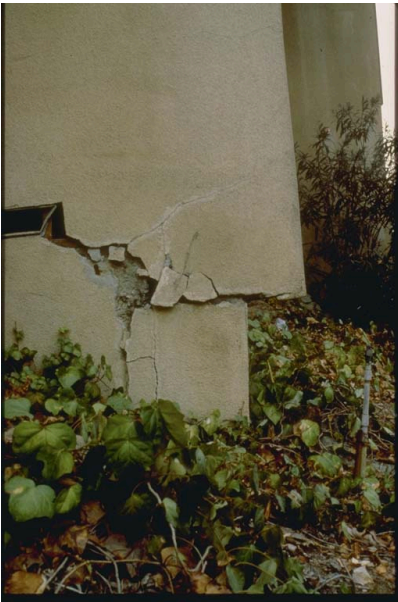
Shift of Apartment Building in 1987 Whittier, CA Earthquake Earthquake of October 1, 1987, Whittier Narrows, California. The Garvey West Apartment building in Monterey Park (at Monterey Pass Road in Garvey) shifted about 10 inches to the east on its foundation. Shown here is the southeast corner of the building. [Photo credit: G. Reagor, U.S. Geological Survey.]

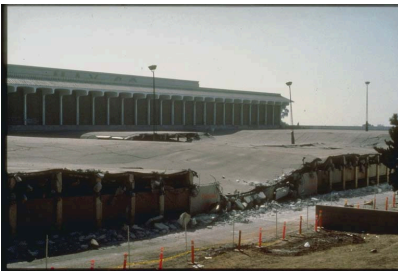
Partial Collapse of Parking Garage, Whittier, CA, 1987 Earthquake Earthquake of October 1, 1987, Whittier Narrows, California. Partial collapse of the May Company's three-level parking garage at Quad Shopping Mall in Whittier. The structure, built in 1965, is located at the corner of Whittier Boulevard and Painter Avenue. [Photo credit: G. Reagor, U.S. Geological Survey.]

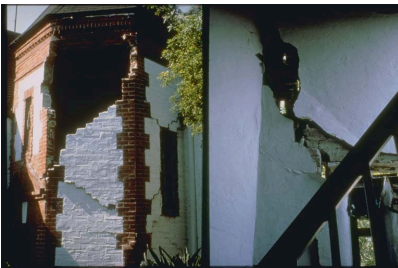
Exterior View of Damaged Residence, Whittier, CA 1987 Earthquake

Earthquake of October 1, 1987, Whittier Narrows, California. Left: Exterior view of a badly damaged brick residence in the 5000 block of Bright Street in North Whittier. Right: Interior view shows cracks extending through the outside wall of structure. [Photo credit: G. Reagor, U.S. Geological Survey.]

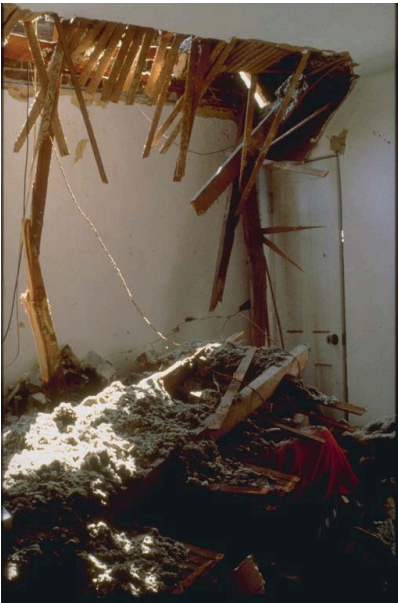
Interior View of Damaged Residence, Whittier, CA 1987 Earthquake

Earthquake of October 1, 1987, Whittier Narrows, California. Collapse of the chimney through the roof of the same residence (see slide 18). The chimney fell onto the bed of a four-year old boy who was rescued and hospitalized with a broken collar bone. [Photo credit: G. Reagor, U.S. Geological Survey.]

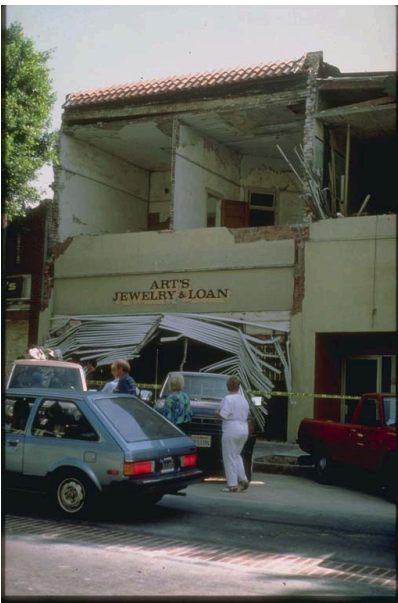
Collapse of Wall of Store in 1987 Whittier, CA Earthquake Earthquake of October 1, 1987, Whittier Narrows, California. Collapse of the wall on the second story of Art's Jewelry and Loan establishment on Greenleaf Avenue in "Uptown Whittier." This older section in north Whittier sustained serious damage. At least 200 residences and 30 businesses were badly damaged. Most of the severe damage was to structures built before 1930. [Photo credit: G. Reagor, U.S. Geological Survey.]
