Geologic Hazards Photos Volume 2

Earthquake Events

Cape Mendocino Earthquakes: An Illustration of the Effects of a Moderately Large Earthquake in a Sparsely Settled Area

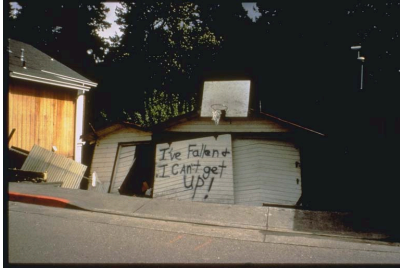
Garage slid down hill due to earth shaking This garage slid down hill due to the earth shaking in Rio Dell, a town of 2,900. The garage extended out over the north bank of the Eel River. The garage was supported by a framework of wooden stilts. The stilts collapsed and the garage fell backwards from street level. Other buildings in the neighborhood had similar damage, but the damage was not as severe or as impressive. This neighborhood was an older residential area which lay just south of the business district of Rio Dell and followed the Eel River bank. A total of twelve homes were destroyed, and 57 sustained major damage in Rio Dell. On Main Street fifteen out of twenty of the older one and two-story buildings incurred damage including broken glass, fallen bricks, and cracked plaster. Buildings shifted as much as two feet from their pre-earthquake positions. The earthquake caused contamination of water supply systems, broke water mains and sewer pipes, and interrupted telephone, gas and electricity services. The total earthquake damage was estimated at \$8 million. Photograph credit: Lindie Brewer, U.S. Geological Survey.

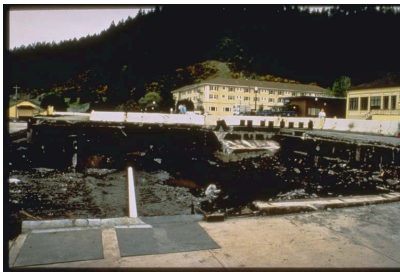
View of mall at Scotia that was destroyed by earthquake-caused fire The view shows the area destroyed by the fire in Scotia. It is believed that the fire early Sunday, April 26th, resulted from an electrical short caused by the earthquake. Before the fire, the mall consisted of five one-to two-story, wood-frame, commercial buildings including a lumber yard, a pharmacy, a coffee shop, a grocery store and a Ben Franklin Variety Store. While local firemen were attempting to save the mall, the second major shock occurred which snapped the town's water main. Firemen drew water from a nearby log pond, in order to continue fighting the fire. Scotia, a 123-year-old town lies north of Rio Dell across the Eel River. The two towns are joined by bridges across the Eel River. Fifty homes were damaged and a shopping center consisting of five stores burned to the ground. As in Rio Dell, water mains and sewer pipes were broken and water supply systems contaminated. Telephone, gas and electricity services were interrupted. Total damage was estimated at between \$10 and \$15 million. Photograph credit: Lindie Brewer, U.S. Geological Survey.

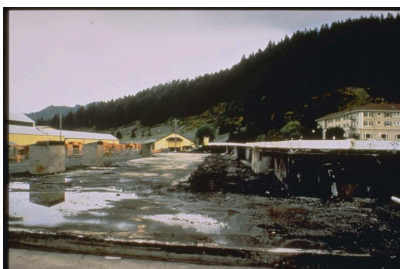
Second view of Scotia mall A second view of the mall in Scotia that was destroyed by a fire. It is believed that the fire early Sunday, April 26th, resulted from an electrical short caused by the earthquake. Before the fire, the mall consisted of five one-to two-story, wood-frame, commercial buildings including a lumber yard, a pharmacy, a coffee shop, a grocery store and a Ben Franklin Variety Store. While local firemen were attempting to save the mall, the second major shock occurred which snapped the town's water main. Firemen drew water from a nearby log pond, in order to continue fighting the fire. Scotia, a 123-year-old town lies north of Rio Dell across the Eel River. The two towns are joined by bridges across the Eel River. Fifty homes were damaged and a shopping center consisting of five stores burned to the ground. As in Rio Dell, water mains and sewer pipes were broken and water supply systems contaminated. Telephone, gas and electricity services were interrupted. Total damage was estimated at between \$10 and \$15 million. Photograph credit: Lindie Brewer, U.S. Geological Survey.

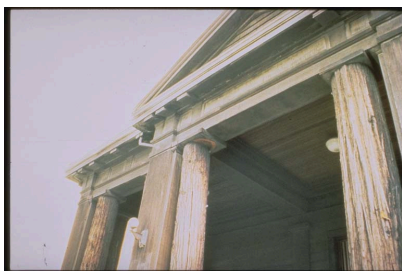
Support pillar on Scotia's Lumber Museum A redwood support pillar at the top of the portico that covered the front entrance to the Lumber Museum in Scotia shifted during the earthquake. The Lumber Museum is located on Scotia's Main Street, just across the street from the burned out mall. Although the museum was closed, other exterior damage was to windows which were either cracked or broken out. After the quake sheets of plywood covered the damaged windows. Photograph credit: Lindie Brewer, U.S. Geological Survey.

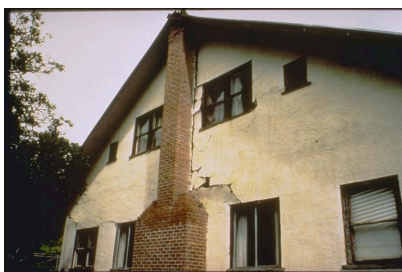
Damage to 70-year old house and chimney in Honeydew This 2-story, wood-frame, stucco-veneer house in Honeydew was severely cracked when the chimney pulled away from the house. The east-west sway of the 70-year old structure during the earthquake caused the separation between the chimney and the house. The house was vacant at the time. In this town, close to the epicenter, houses were shifted on foundations; cupboards were emptied; and brick chimneys fell. The single-story, wood-frame building where the post office and general store were located showed no signs of movement on its foundation. Photograph credit: Lindie Brewer, U.S. Geological Survey.

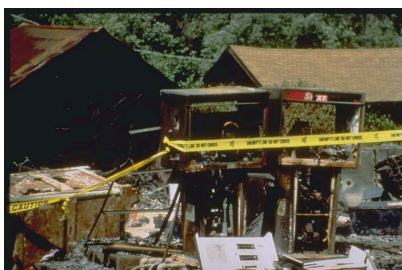
Remains of Petrolia's business district after earthquake and fire This slide shows the remains of the business district in Petrolia after the earthquake-related fire burned the Post Office and the 100-year-old general store. Downtown Petrolia consisted of a post office, a 100-year old general store, a gas station, and a volunteer fire station. The post office, gas station, and the general store burned to the ground in an earthquake-related fire. The door of the fire station was jammed by the first large shock. Several firemen were required to raise the door before the fire equipment could be removed. The fire station was later condemned. Buildings that had been recently constructed performed well during the earthquakes with little or no damage. However, damage was severe to poorly-built or poorly-designed structures. One and two story, wood frame houses and commercial buildings were the most common type of construction. A total of five homes were destroyed, 28 sustained major damage, and 25 required minor repairs. Total damage was estimated at \$1 million. As in other towns in Humboldt County, services including water, sewer, telephone, gas and electricity were interrupted. Photograph credit: Lindie Brewer, U.S. Geological Survey.

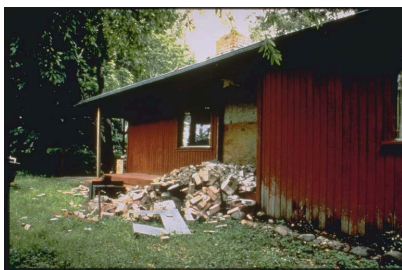
Chimney damage in Petrolia This brick chimney, typical of many others in Petrolia, was toppled due to the severe earth shaking. Other chimneys (even those with steel rods) were broken, or cracked. The inside fireplace in this house was also shattered. Photograph credit: Lindie Brewer, U.S. Geological Survey.

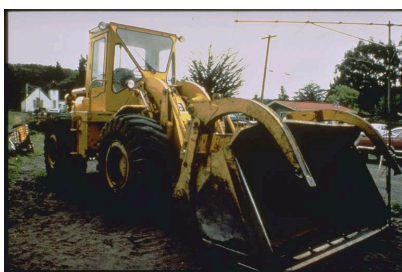
Earthquake bounced this front-end loader one foot into the air This large front-end loader, located in a residential neighborhood of Petrolia about three blocks east of the burned business district, reportedly was bounced one foot into the air. On this same street, new homes of good construction were not damaged; nearby an older, wood-frame home was severely damaged when it was partially shirred off its foundation. Photograph credit: Lindie Brewer, U.S. Geological Survey.

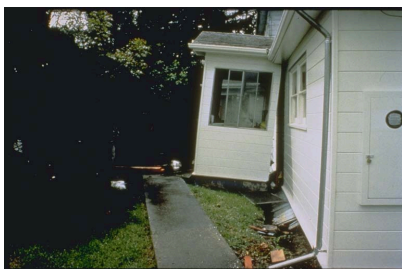
Petrolia residence shifted on foundation This Petrolia residence shifted on its foundation causing the porch to separate from the house. Wooden skirting along the bottom of the house shows the direction of movement of the house on the foundation. Photograph credit: Lindie Brewer, U.S. Geological Survey.

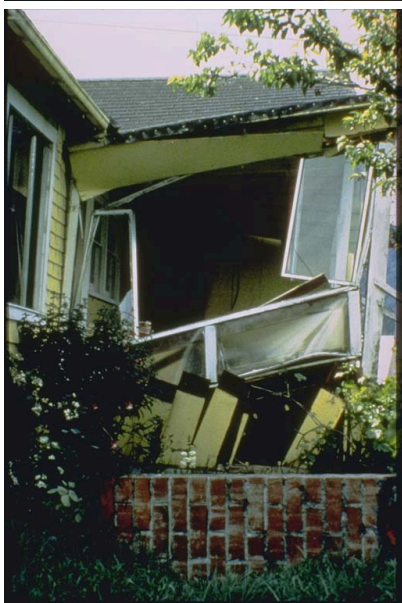
Residence south of Petrolia that shifted off foundation The Christian residence south of Petrolia shifted off its foundation because the house was not anchored to the foundation. The structure, which was declared a total loss by insurance standards, shifted toward the northwest. A primitive post and pier foundation was common in the Petrolia area. This view shows separation of the porch from the rest of the structure. The house damage was more severe where additions were attached to the original structure. Photograph credit: Lindie Brewer, U.S. Geological Survey.

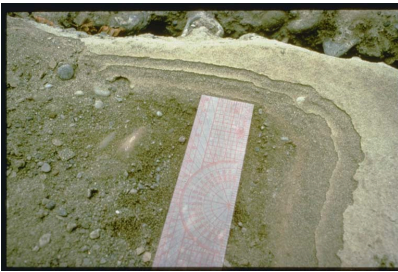
Pier Displacement of Concrete Bridge, Iran OTHER STRUCTURAL DAMAGE

Large lateral pier displacement of undamaged concrete bridge. Although the lateral displacement at the ground level was about 25.4 cm there was no observable damage either to the columns or girders of this bridge. In general bridges performed relatively well in the 1990 Iranian earthquake. Photograph Credit: M. Mehrain, Dames and Moore.
